APPENDIX 1

**Region 9 Enforcement Division
75 Hawthorne Street
San Francisco, CA 94105**

PHILLIPS 66 WILMINGTON PHOTOGRAPH LOG

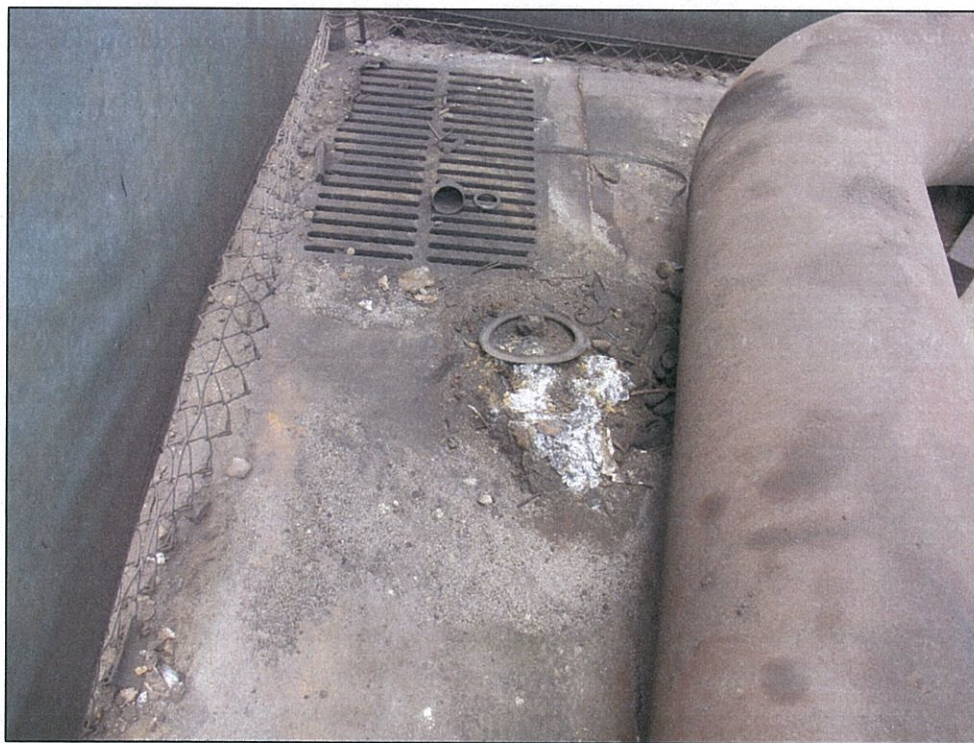
Photograph 1. IMG_0019.jpg - Debris around sump at heat exchange bundle cleaning pad.

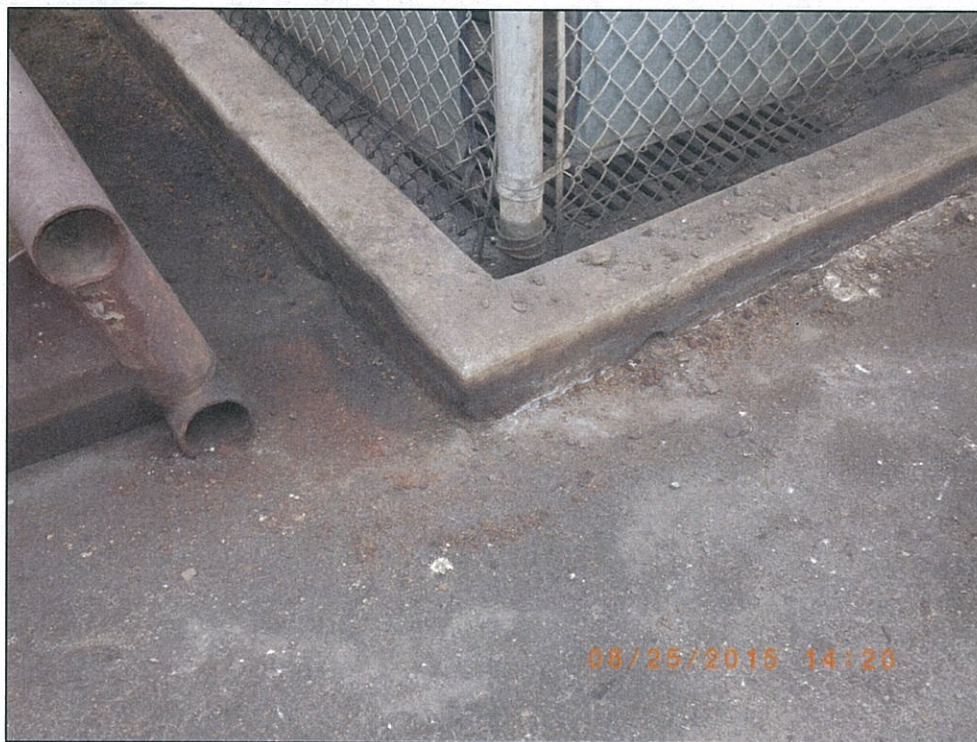
Photograph 2. IMG0250.jpg - Debris outside of secondary containment of heat exchange bundle cleaning pad secondary containment.

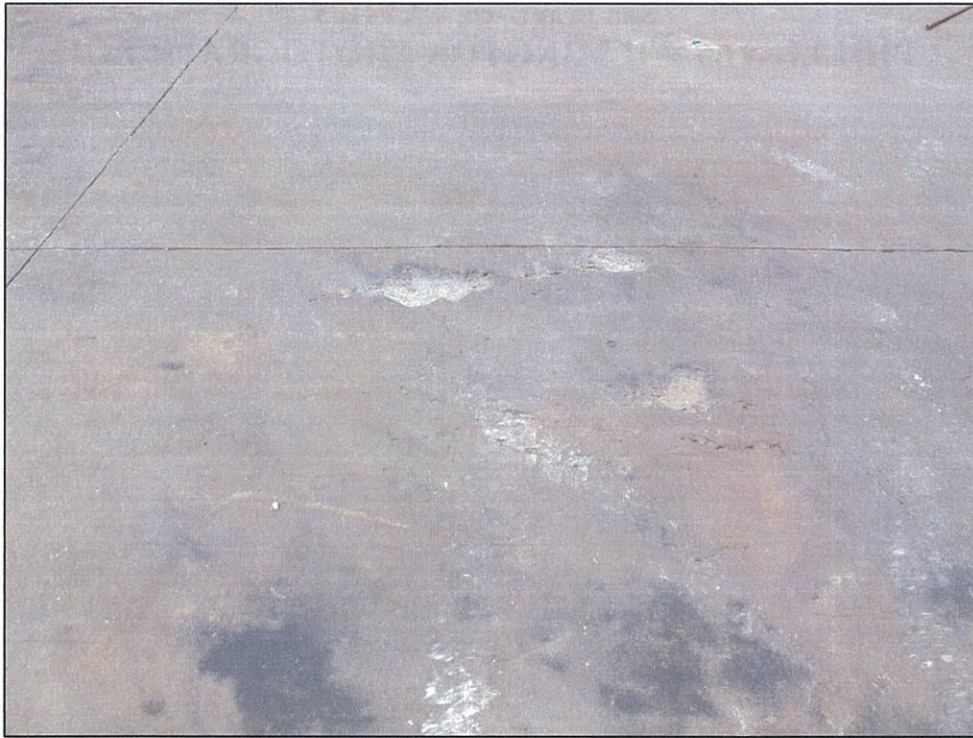
Photograph 3. IMG_0011.jpg - Gouges in heat exchange bundle cleaning pad pavement.

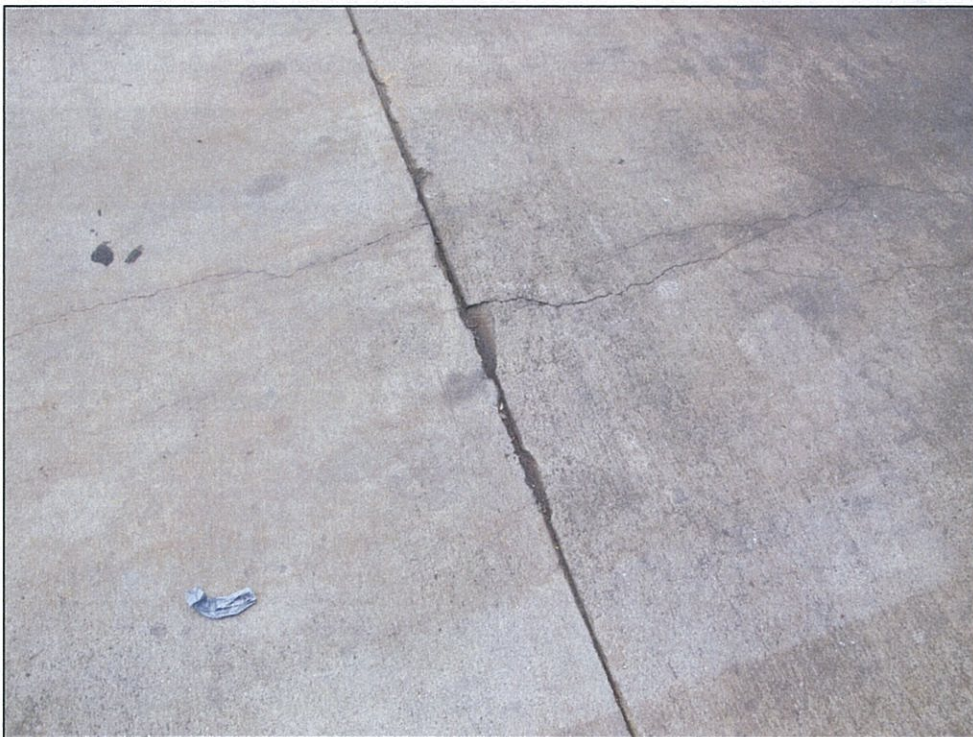
Photograph 4. IMG_0018.jpg - Gouges in heat exchange bundle cleaning pad pavement.

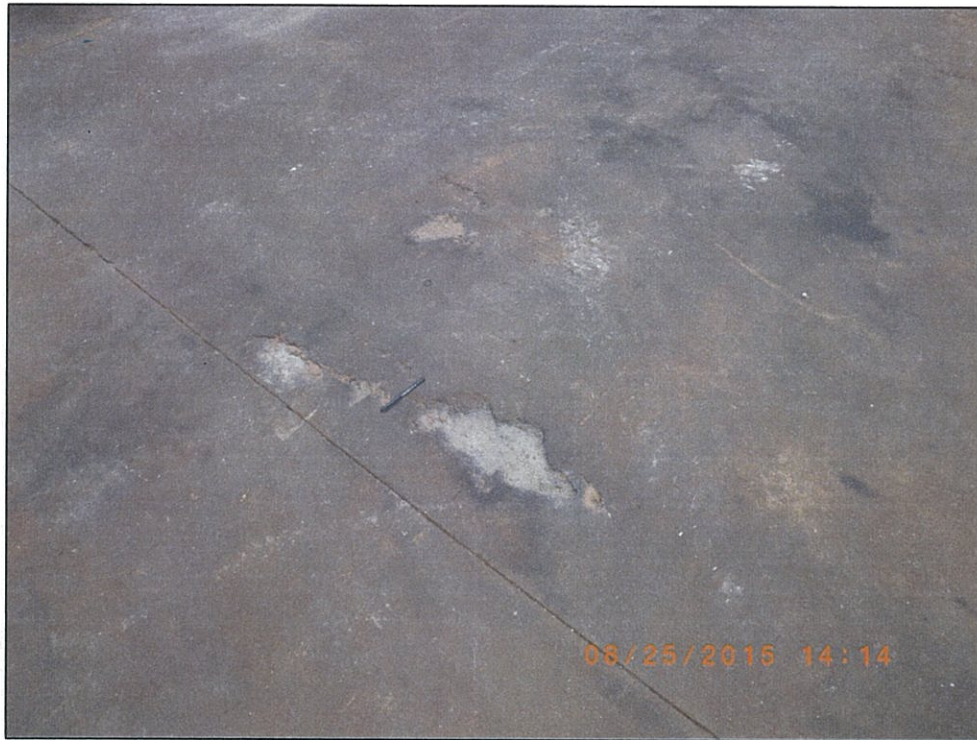
Photograph 5. IMGP0241.jpg - Gouges in heat exchange bundle cleaning pad pavement.

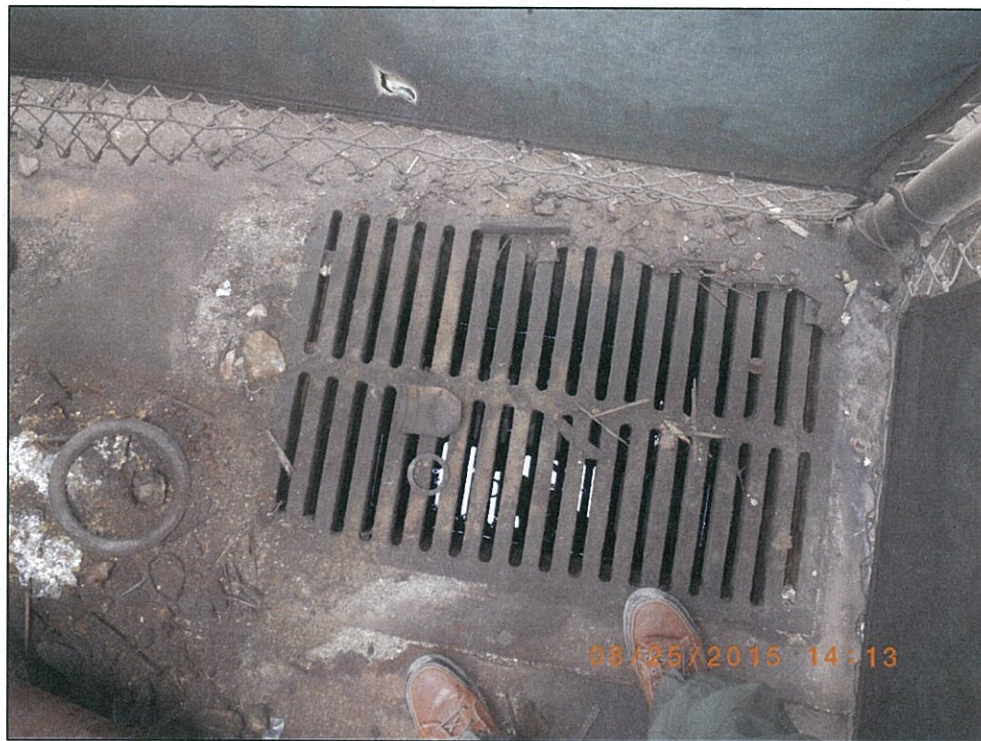
Photograph 6. IMGP0240.jpg - Liquid in heat exchange bundle cleaning pad sump.

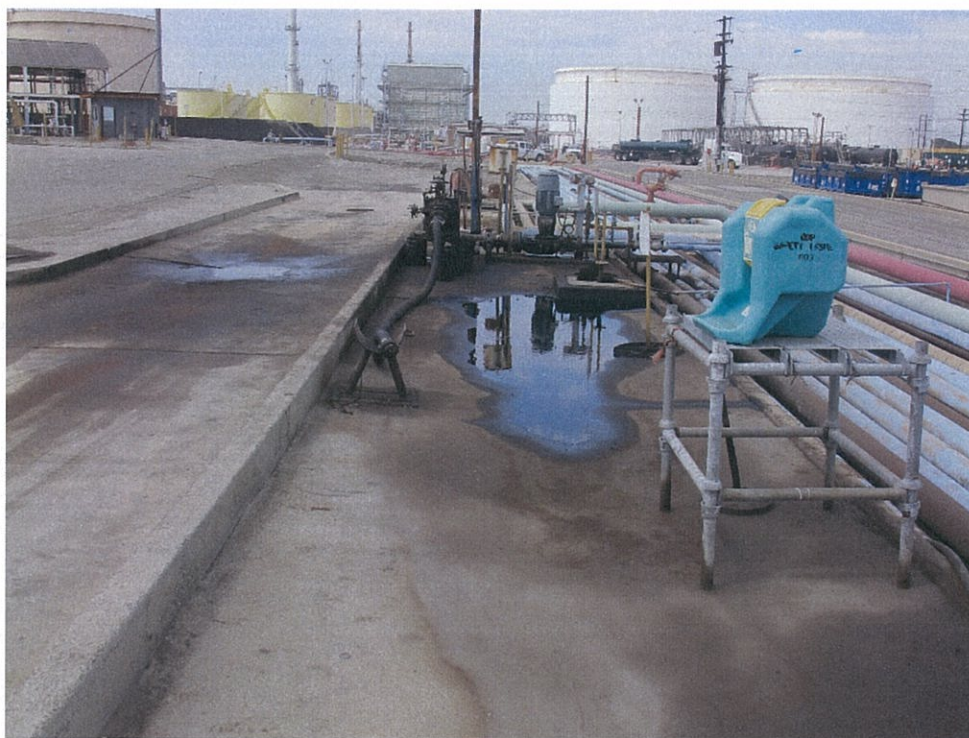
Photograph 7. IMG_0028.jpg - Oily water and debris in the oil truck unloading area adjacent to the hazardous waste accumulation area.

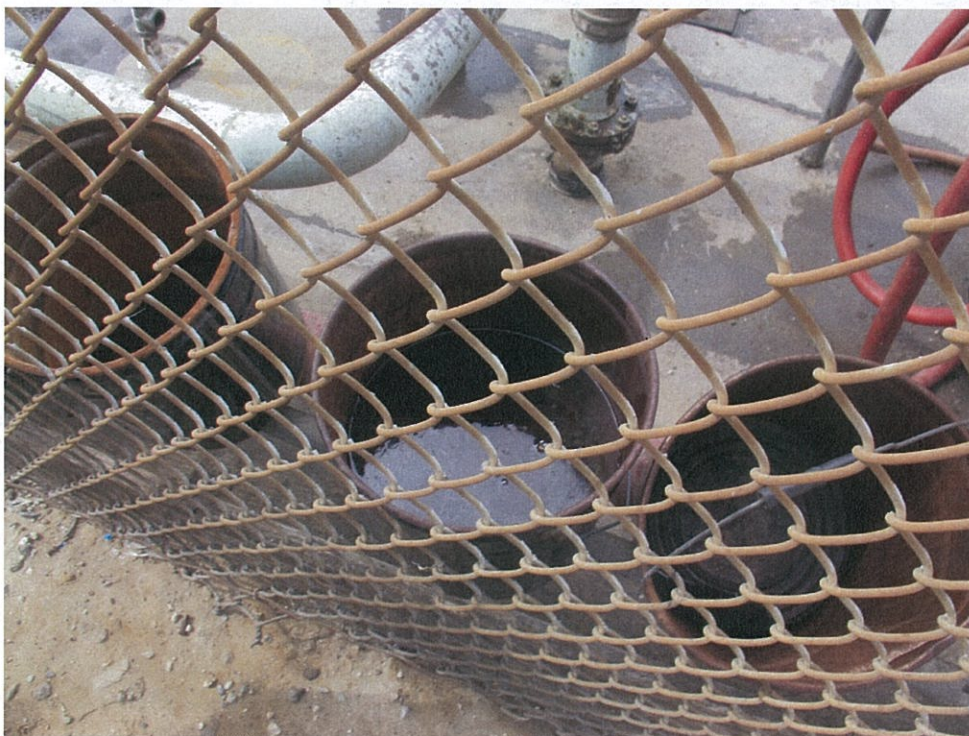
Photograph 8. IMG_0044.jpg - Opened 5-gallon bucket at the vacuum truck unloading area adjacent to the ORU.

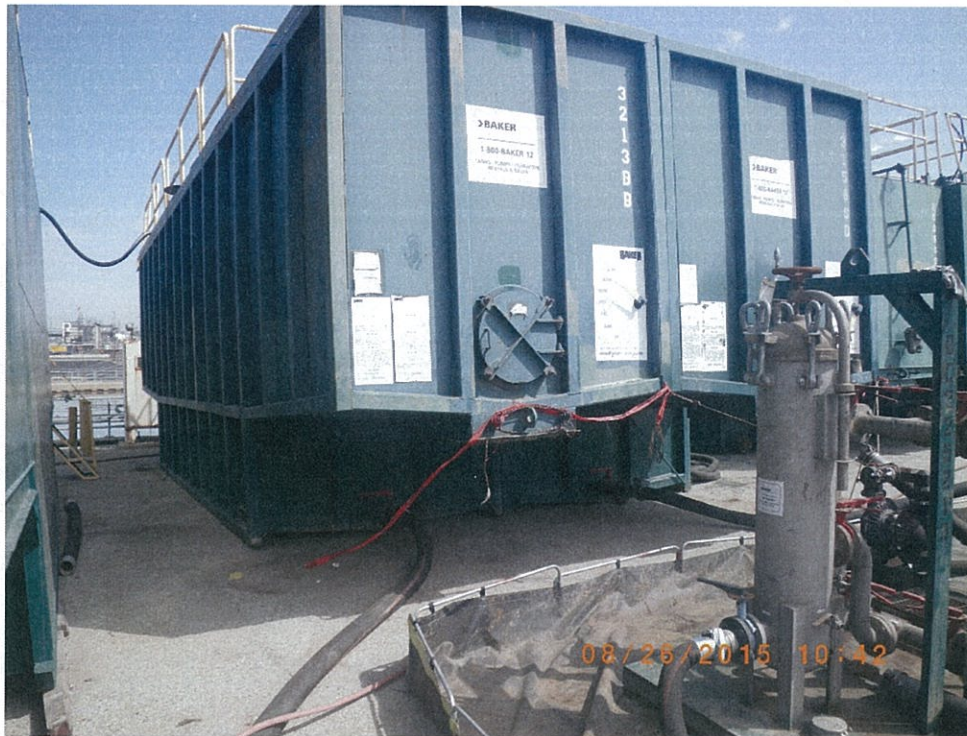
Photograph 9. IMGP0273. Baker tank used to store hazardous waste from Tank cleanout.

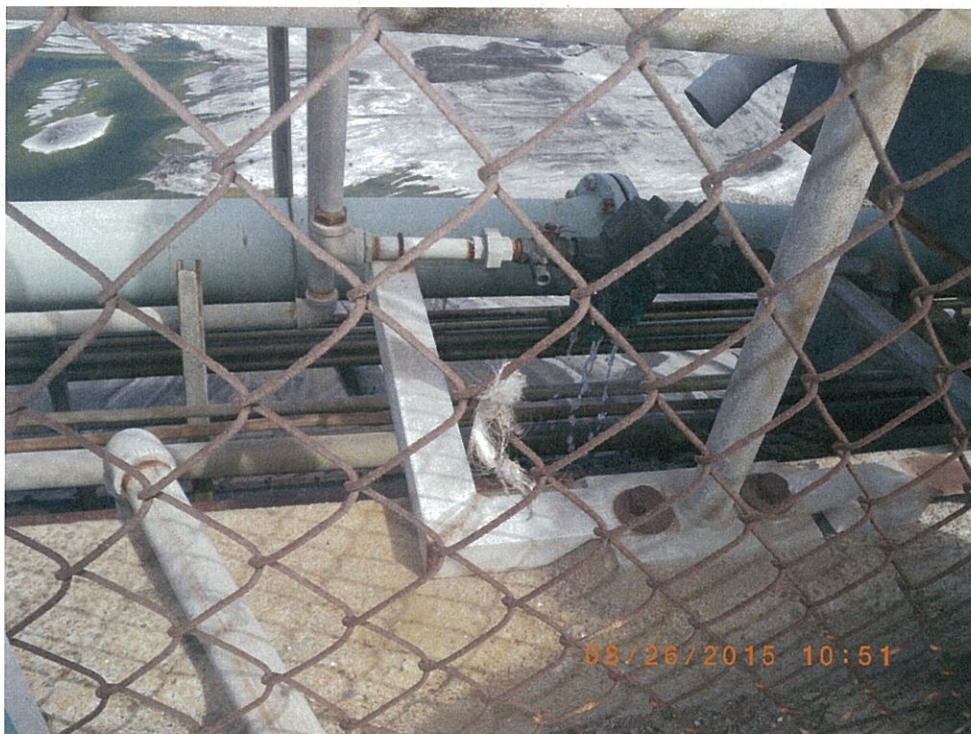
Photograph 10. IMGP0281.jpg - Water leaking from a pipe into the closed oil recovery basin.

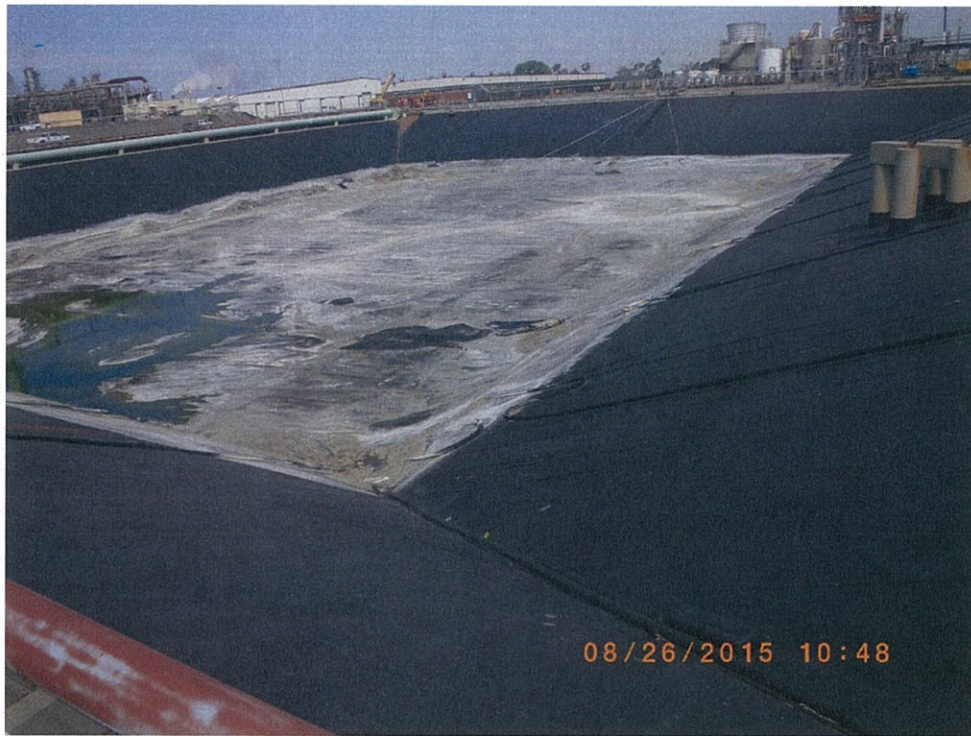
Photograph 11. IMGP0278.jpg - Water and debris in closed oil recovery basin.

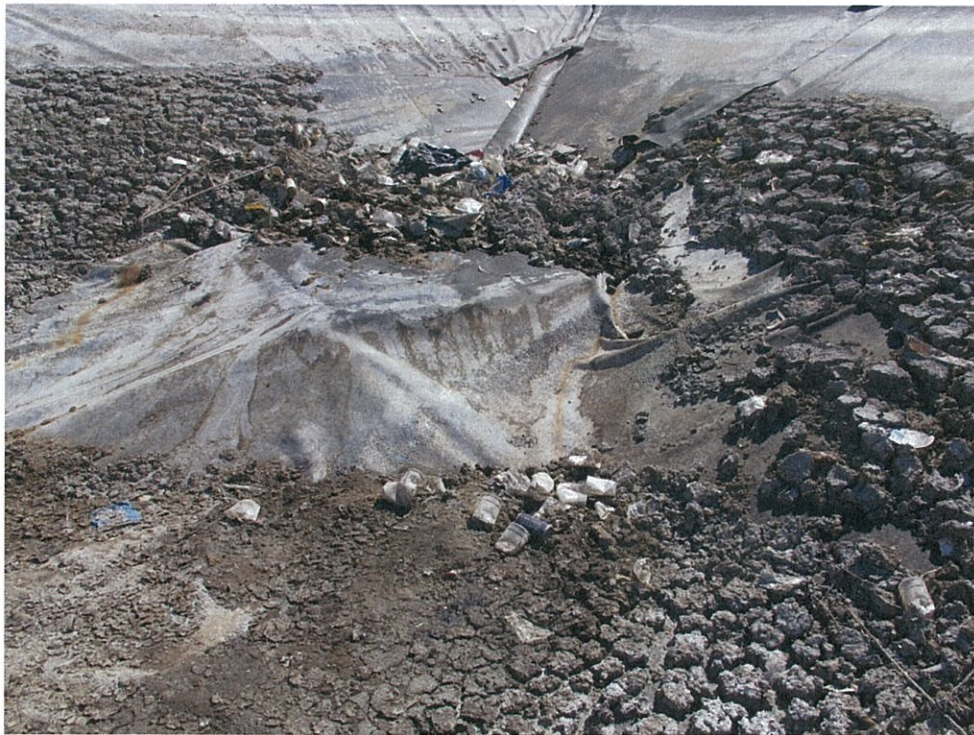
Photograph 12. IMG_0005.jpg - Debris inside closed oil recovery basin.

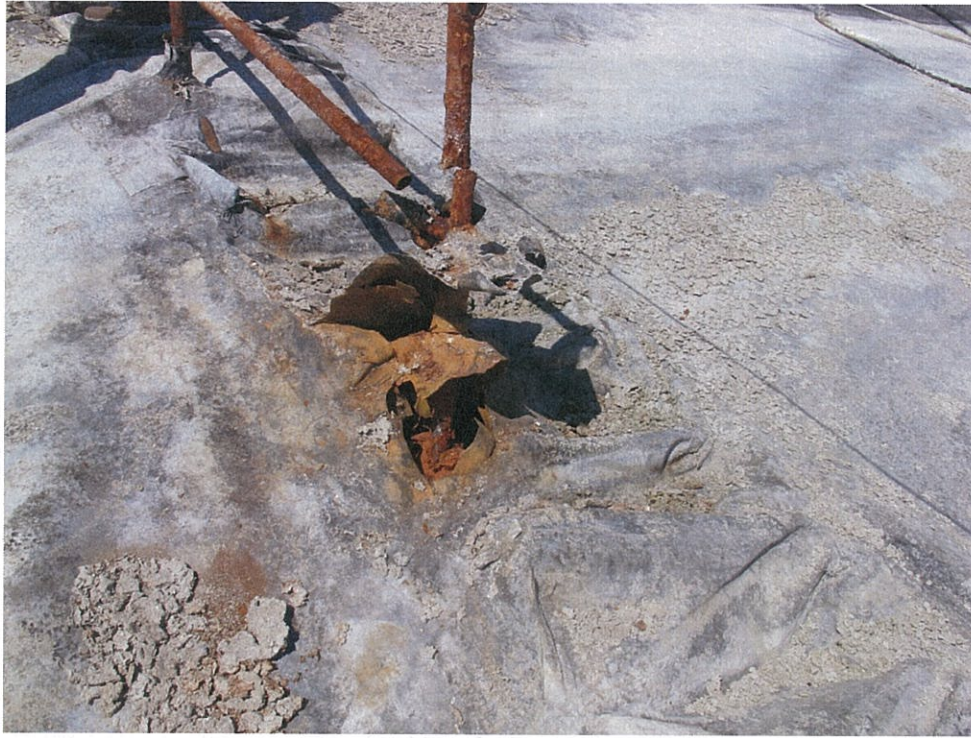
Photograph 13. IMG_0004.jpg - Tear in lining of closed oil recovery basin.

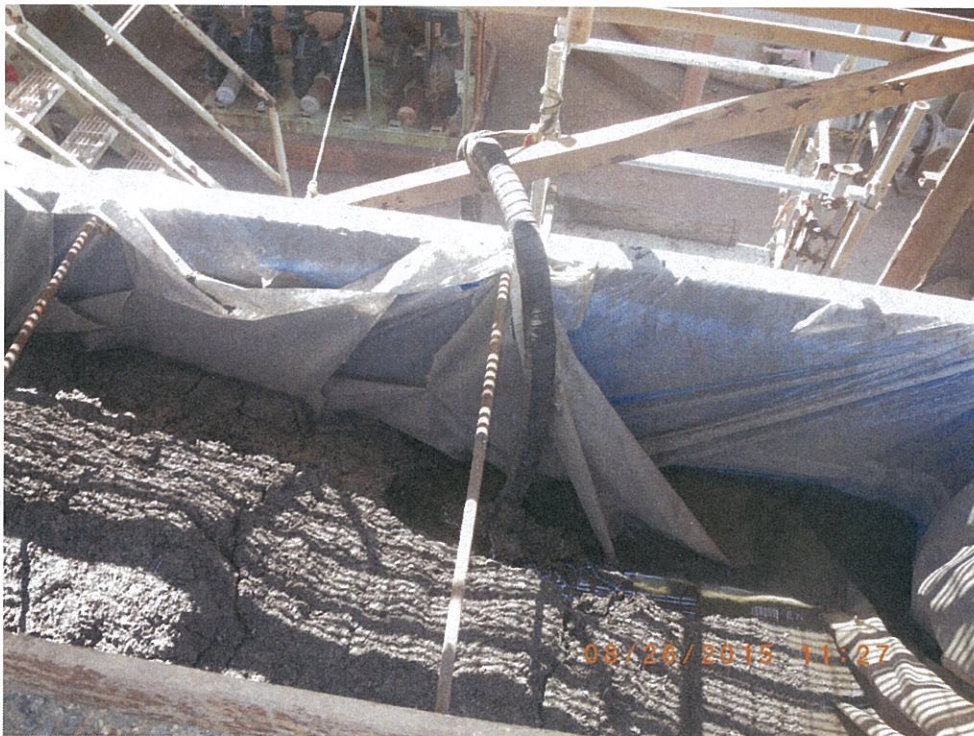
Photograph 13. IMG0294 - Sump pumping liquid out of Selenium plant roll-off bin for filter cakes.

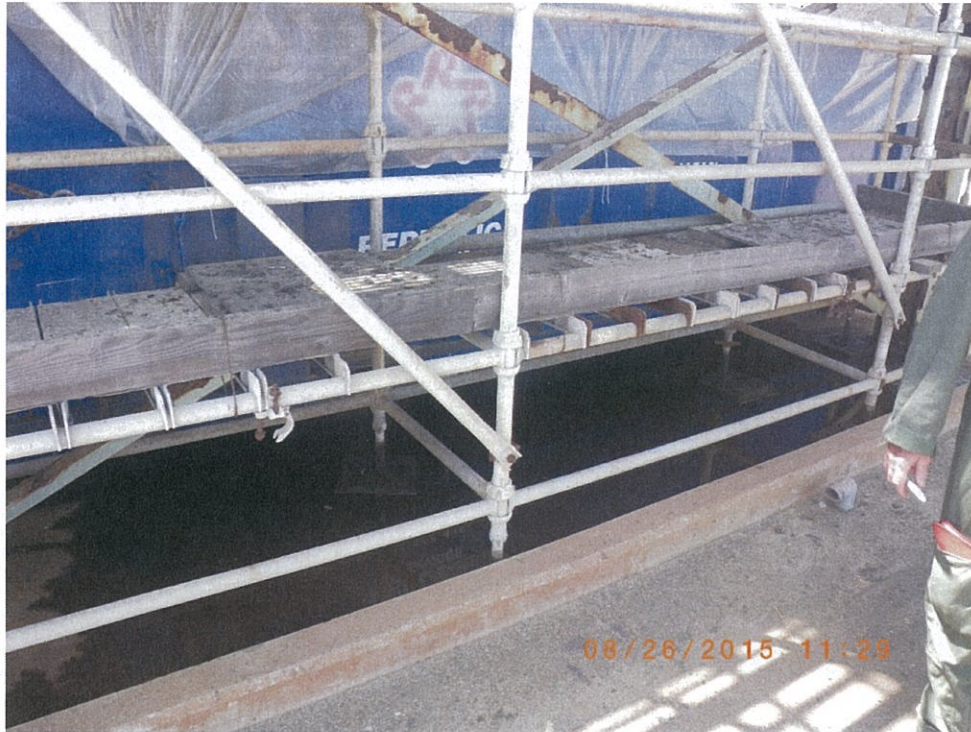
Photograph 14. IMGP0296.jpg - Liquid inside secondary containment of Selenium Plant Roll-off bin secondary containment.

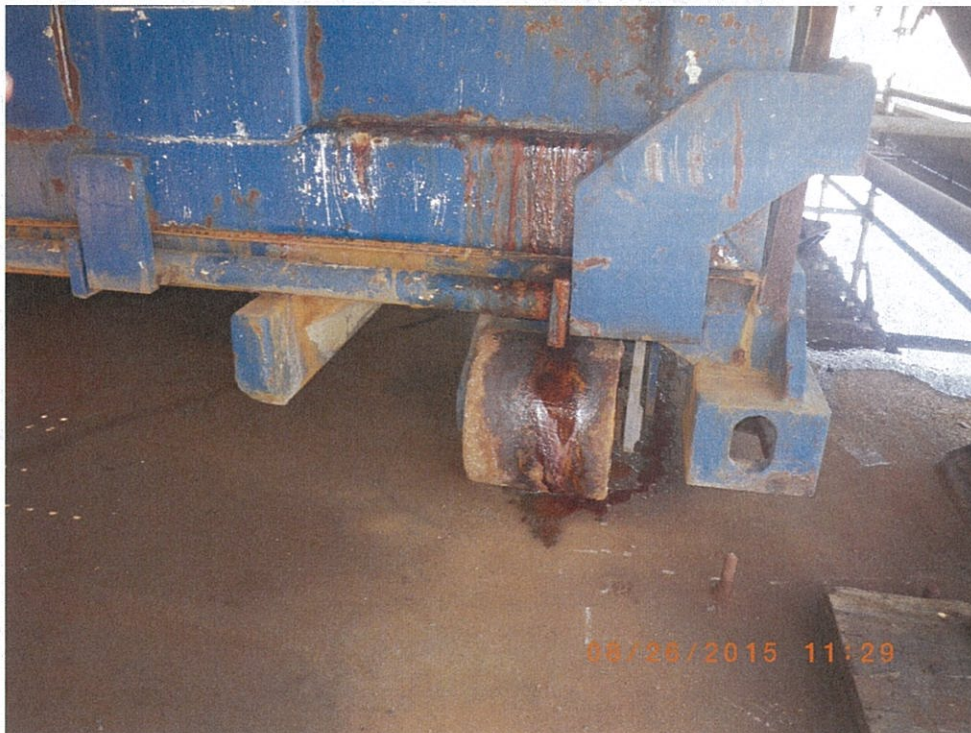
Photograph 145. IMGP0297.jpg - Liquid inside secondary containment of Selenium Plant Roll-off bin secondary containment.

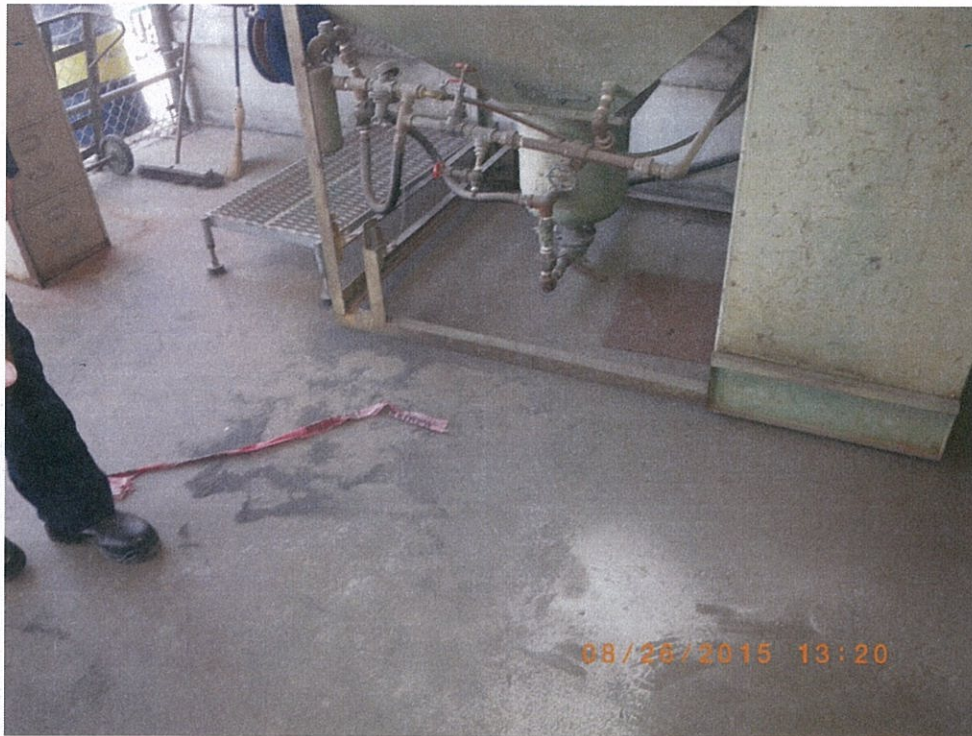
Photograph 156. IMGP0315.jpg - Sand blast grit on the ground in the bead blast room of the maintenance area.

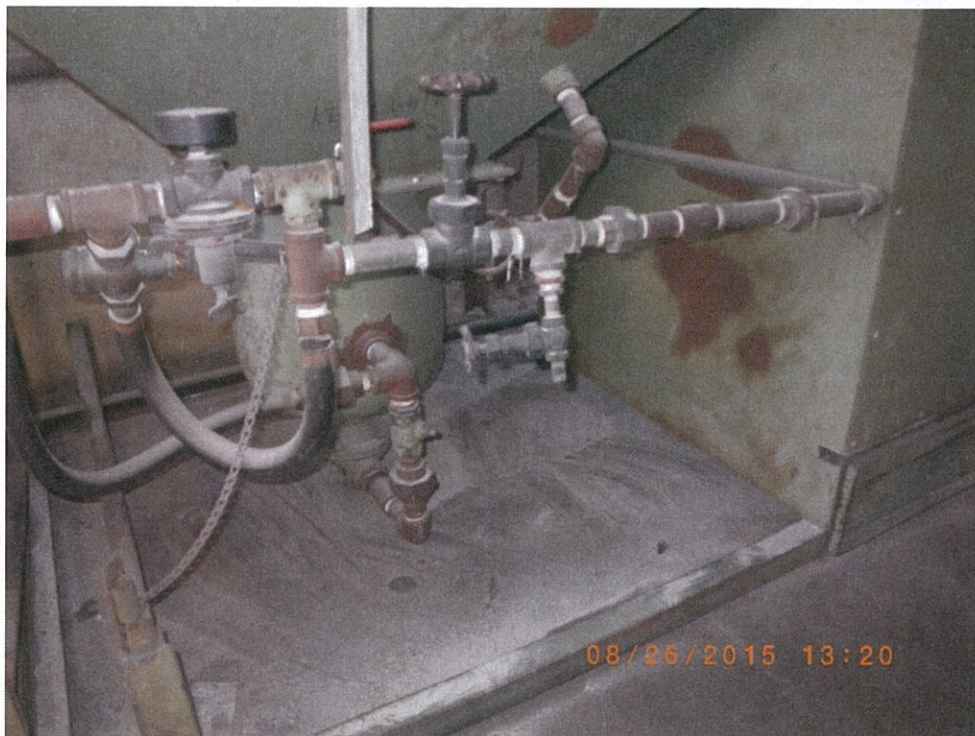
Photograph 167. IMGP0316.jpg - Sand blast grit on the ground in the bead blast room of the maintenance area.

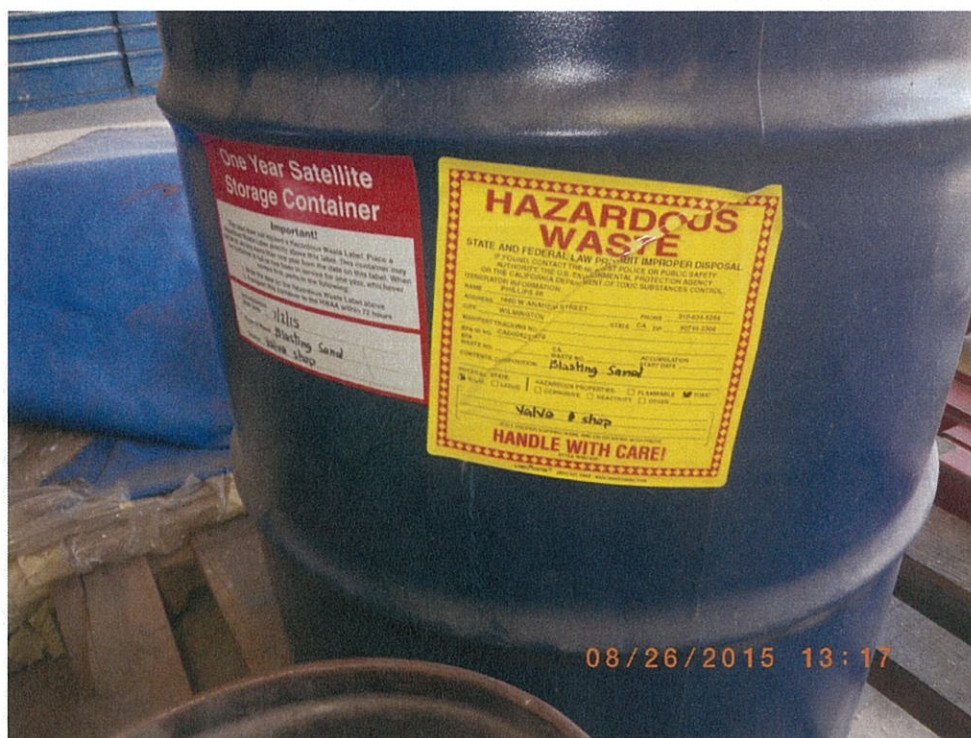
Photograph18. IMGP0314.jpg - No accumulation start date on 55-gallon container of sand blast grit in the bead blast room of the maintenance area.

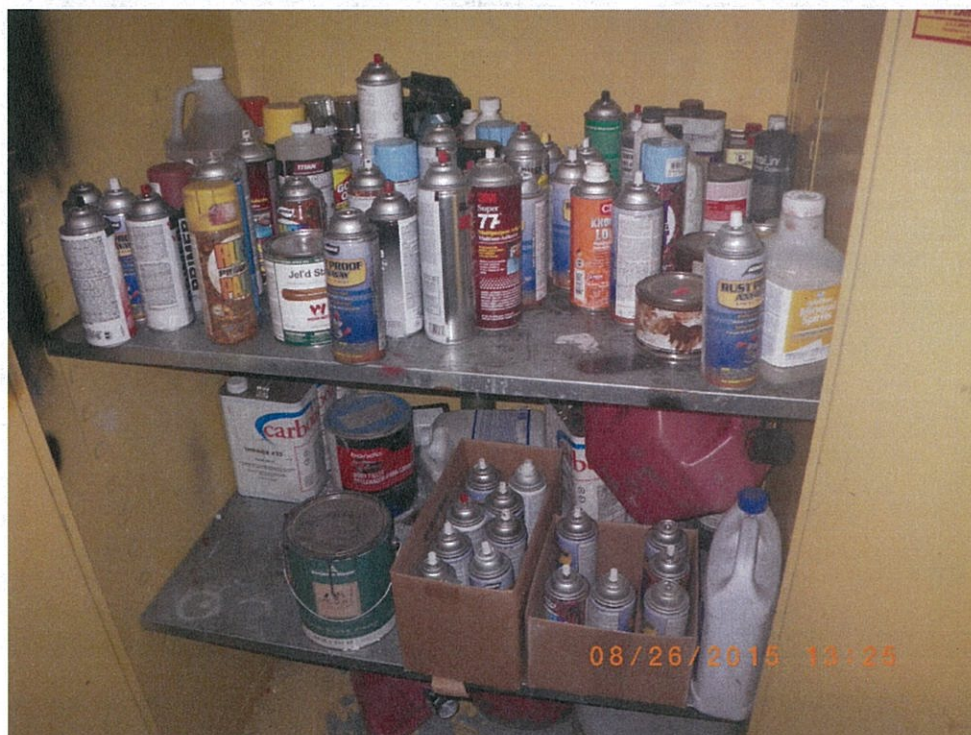
Photograph 19. IMGP0319.jpg - Empty aerosol cans in flammable locker in paint room of maintenance area.

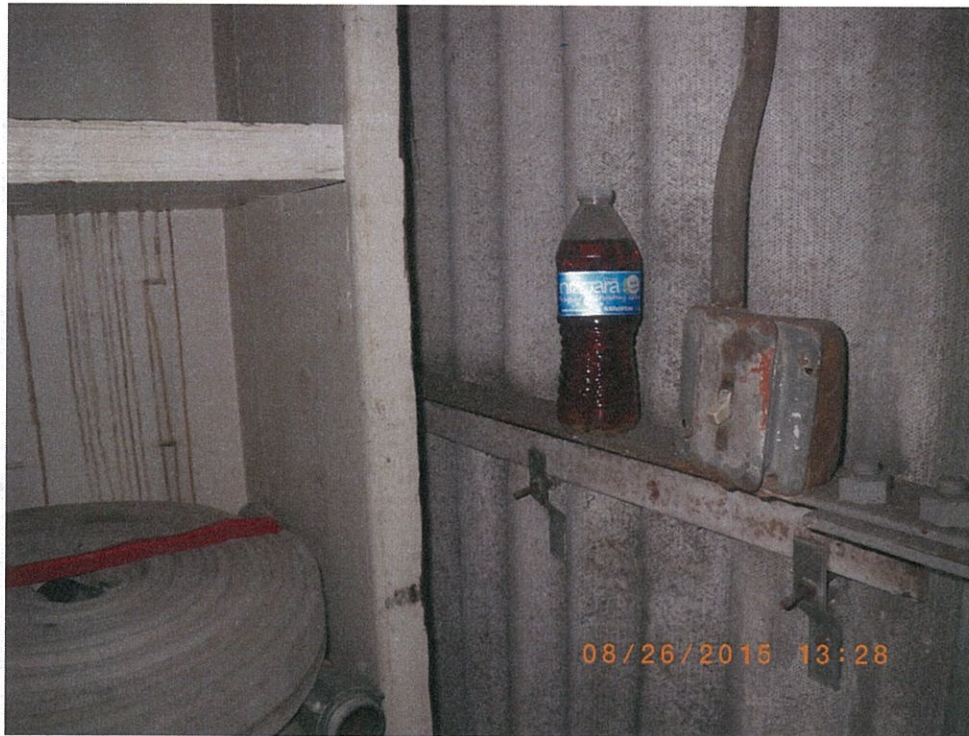
Photograph 17. IMGP0322. Unknown liquid found in Paint Room of Maintenance Area.

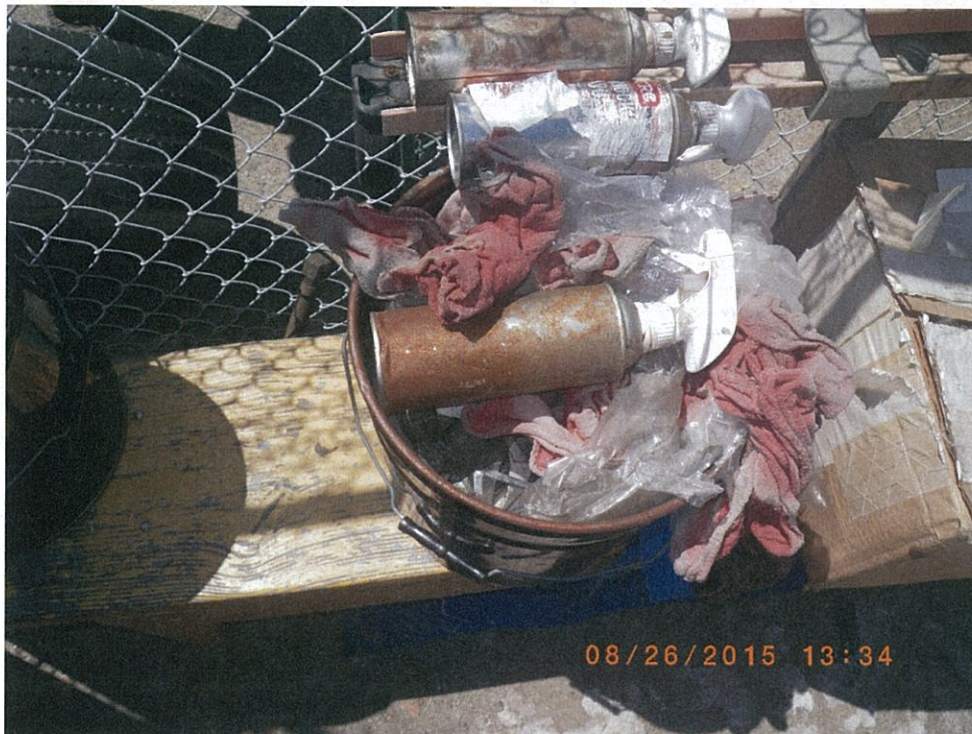
Photograph 18. IMGP0326 - 5-gallon bucket with contaminated materials and empty aerosol cans.

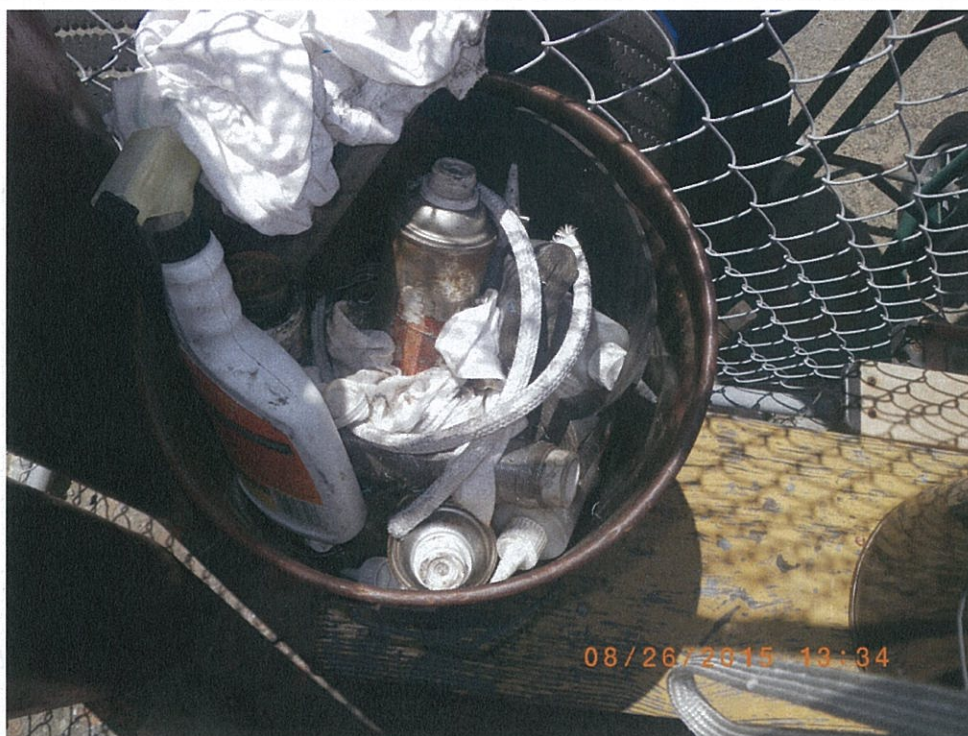
Photograph 19. IMGP0327 - 5-gallon bucket with contaminated materials and empty aerosol cans.

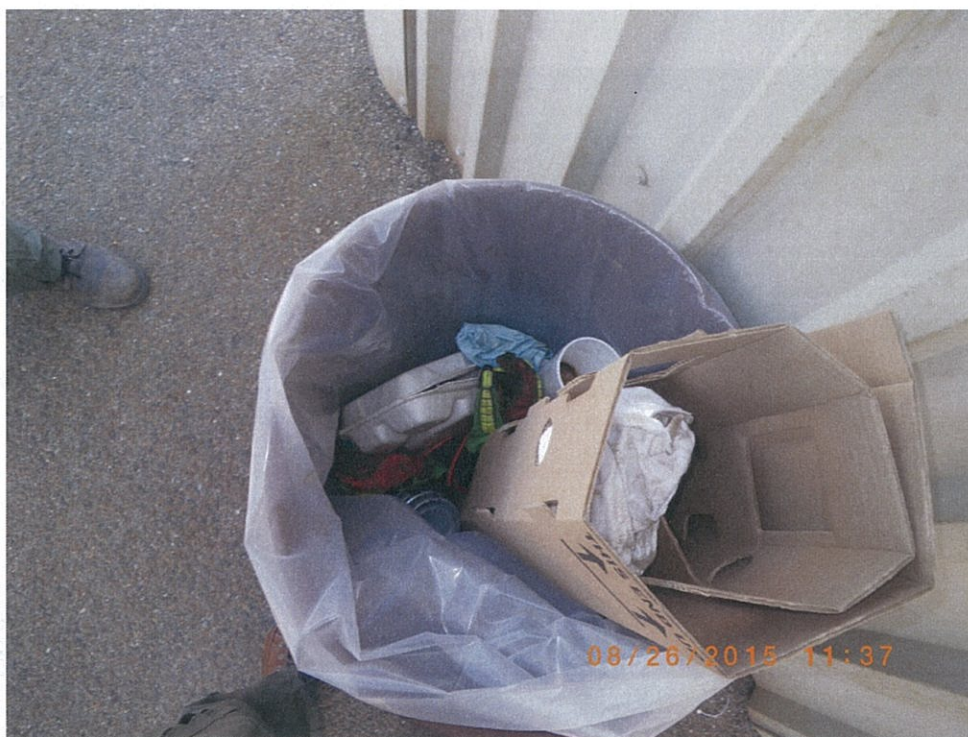
Photograph 20. IMGP0302. Oily contaminated debris found in non-haz trash can.
